DELAWARE RIVER BASIN,  
Tributary of Mill Creek, Berks County,  
Pennsylvania. Phase I Inspection Report,  
SCS PA 476  
BERKS COUNTY, PENNSYLVANIA

NDS I.D. NO. PA 00719  
DER I.D. NO. 6-456

PHASE I INSPECTION REPORT  
NATIONAL DAM INSPECTION PROGRAM

WOODWARD-CLYDE CONSULTANTS  
5120 Butler Pike  
Plymouth Meeting, Pennsylvania 19462

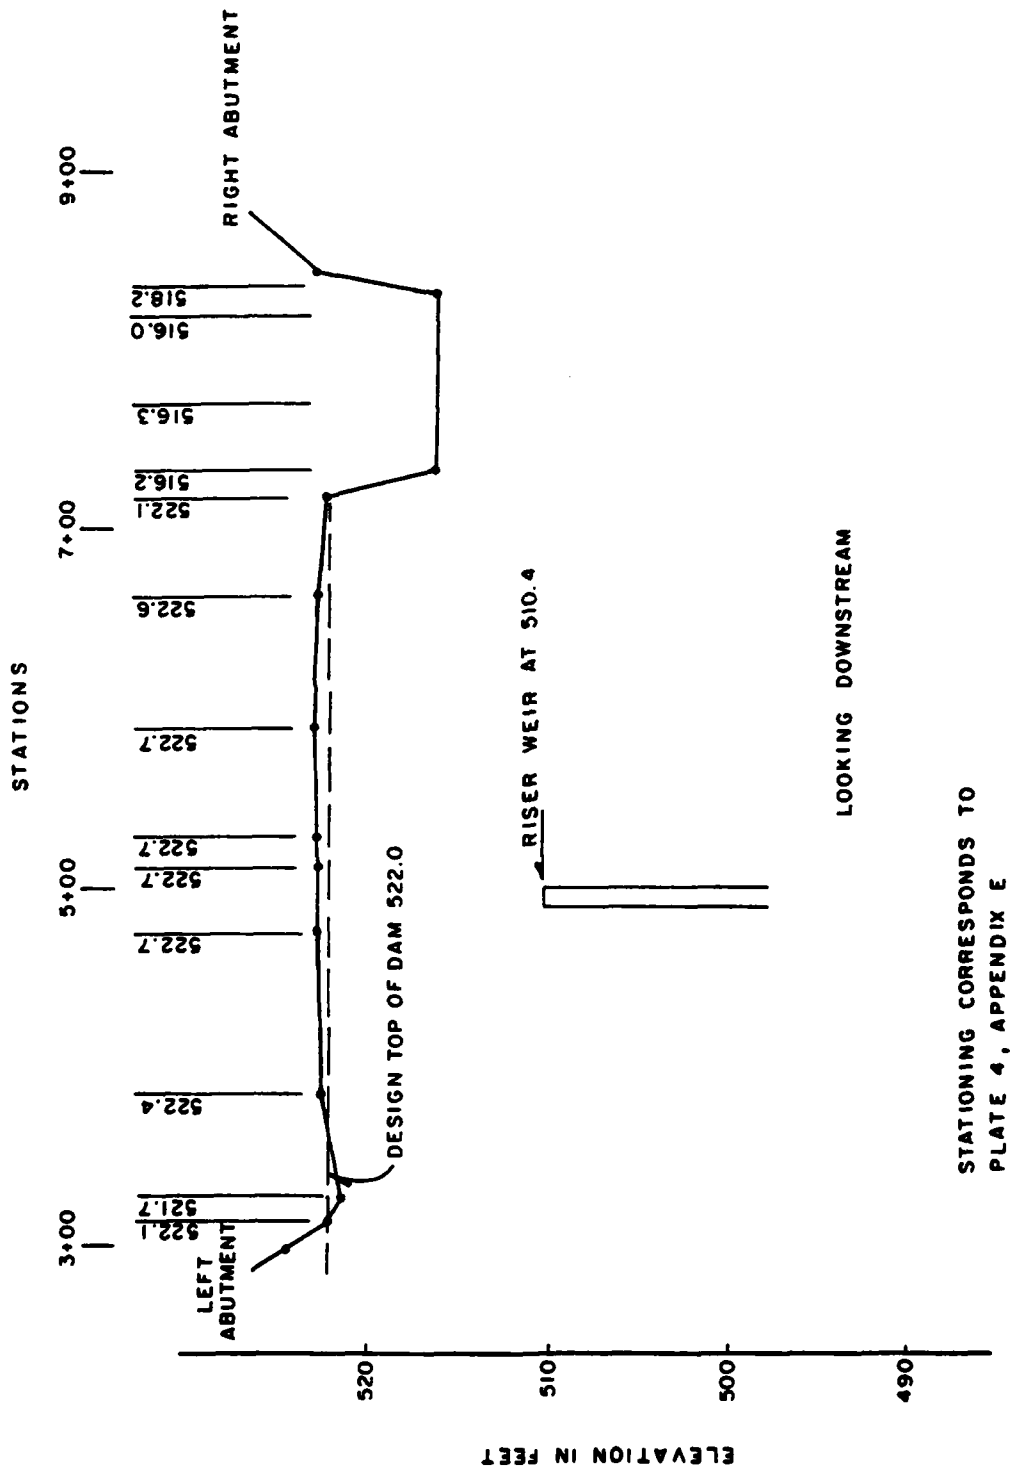
FIELD OBSERVATION PROFILE  
SCS PA 476

The vertical alignment was checked and found to be essentially in agreement with the post-construction survey. A low point of about 521.7 was noted near the left abutment. Junctions between the embankment and abutment and the embankment and spillway are judged to be good, with no excessive erosion or deterioration. There was no seepage observed along or beyond the toe of the dam. The embankment drains outlet through the impact basin wall. A small amount of clear water was flowing from the left drain. It is to be noted that there was a limited head of water behind the embankment at the time of the inspection.
